TOWN OF PELHAM

EAST FENWICK SECONDARY PLAN BACKGROUND REPORT FINAL

SGL Planning & Design | ASI | AE | Matrix Solutions

Town of Pelham
JANUARY 26, 2018 - FINAL

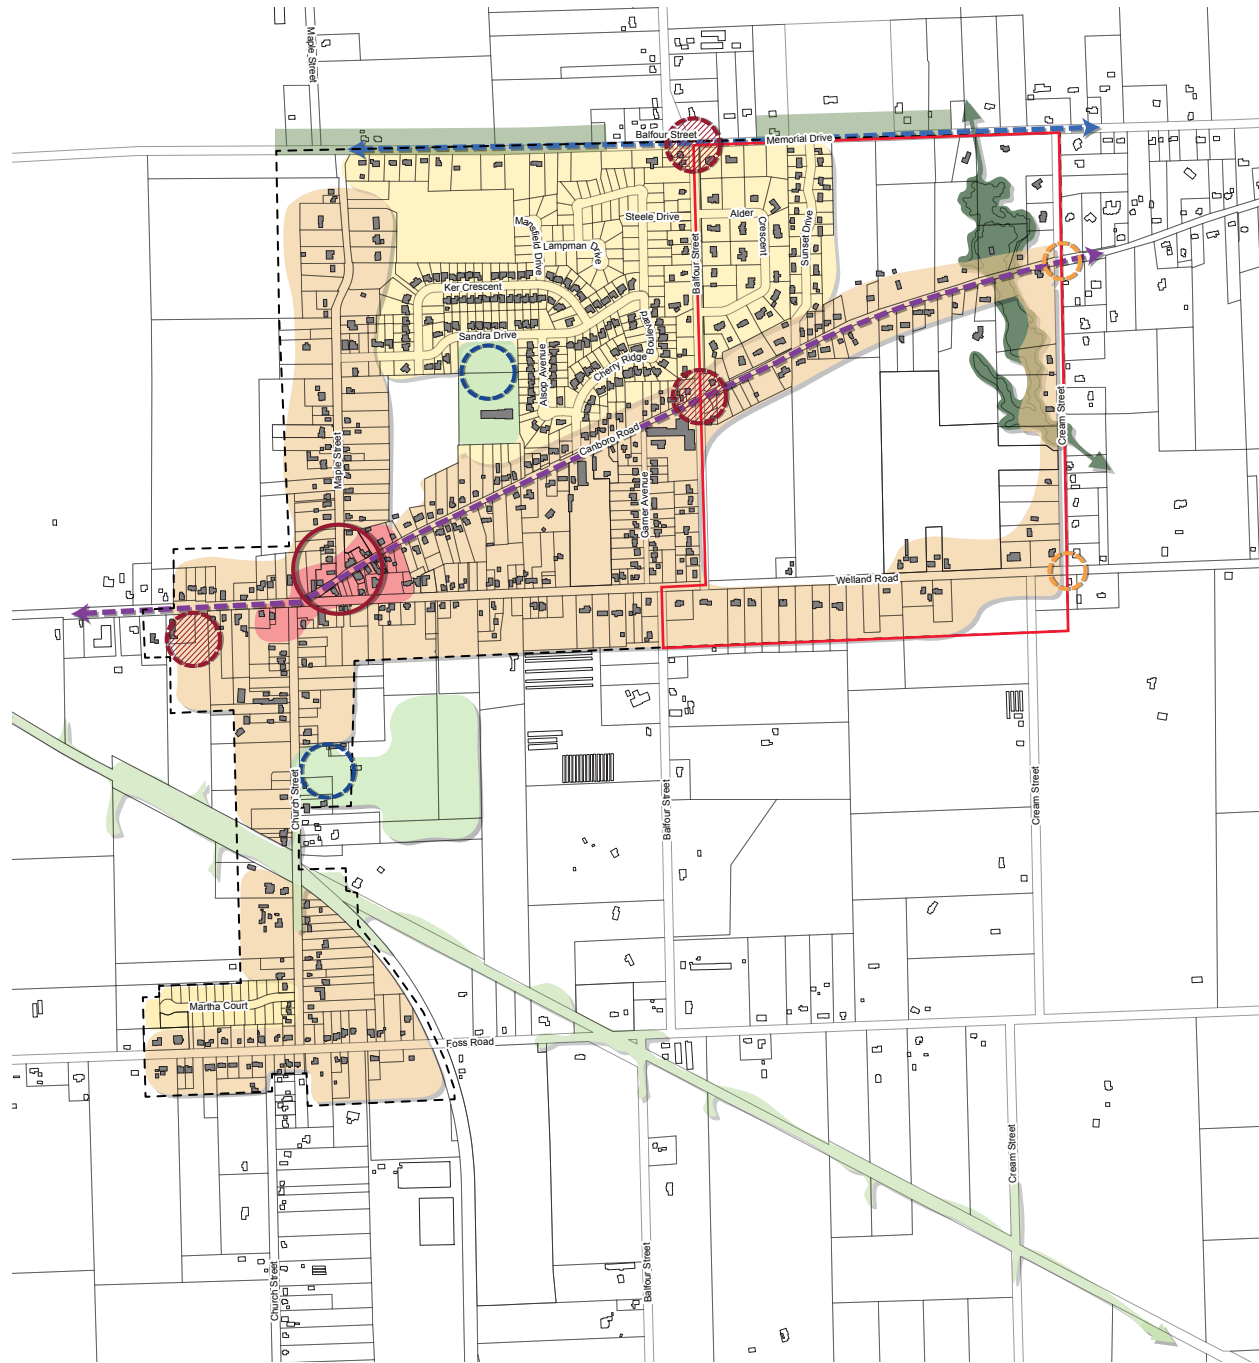
Figure 2. Village Urban Structure

The Village of Fenwick has a distinctive urban structure composed of clearly demarcated downtown and residential areas, focal areas or nodes, landmarks, gateways, a pedestrian network, edge conditions, and vistas. (Refer to Figure 2.Village Urban Structure).

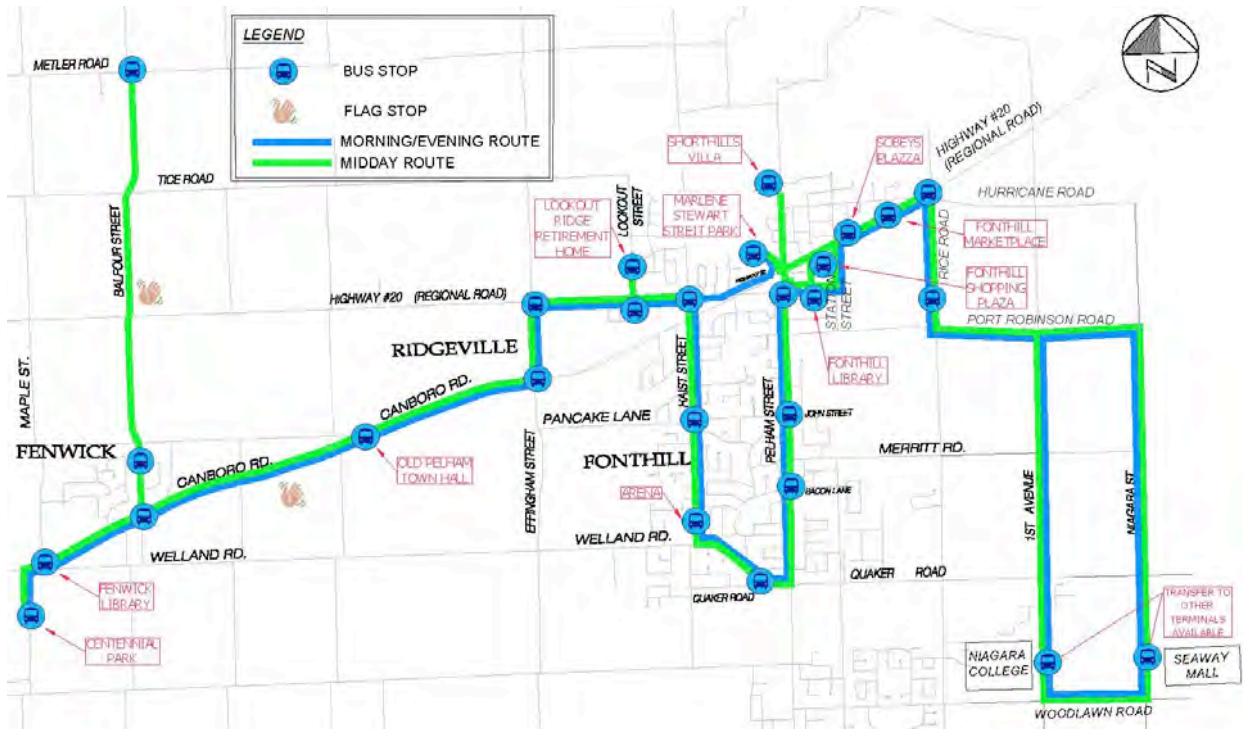
Figure 5. Town of Pelham Transit System

and St. Catharines. (Refer to Figure 5. Town of Pelham Transit System).

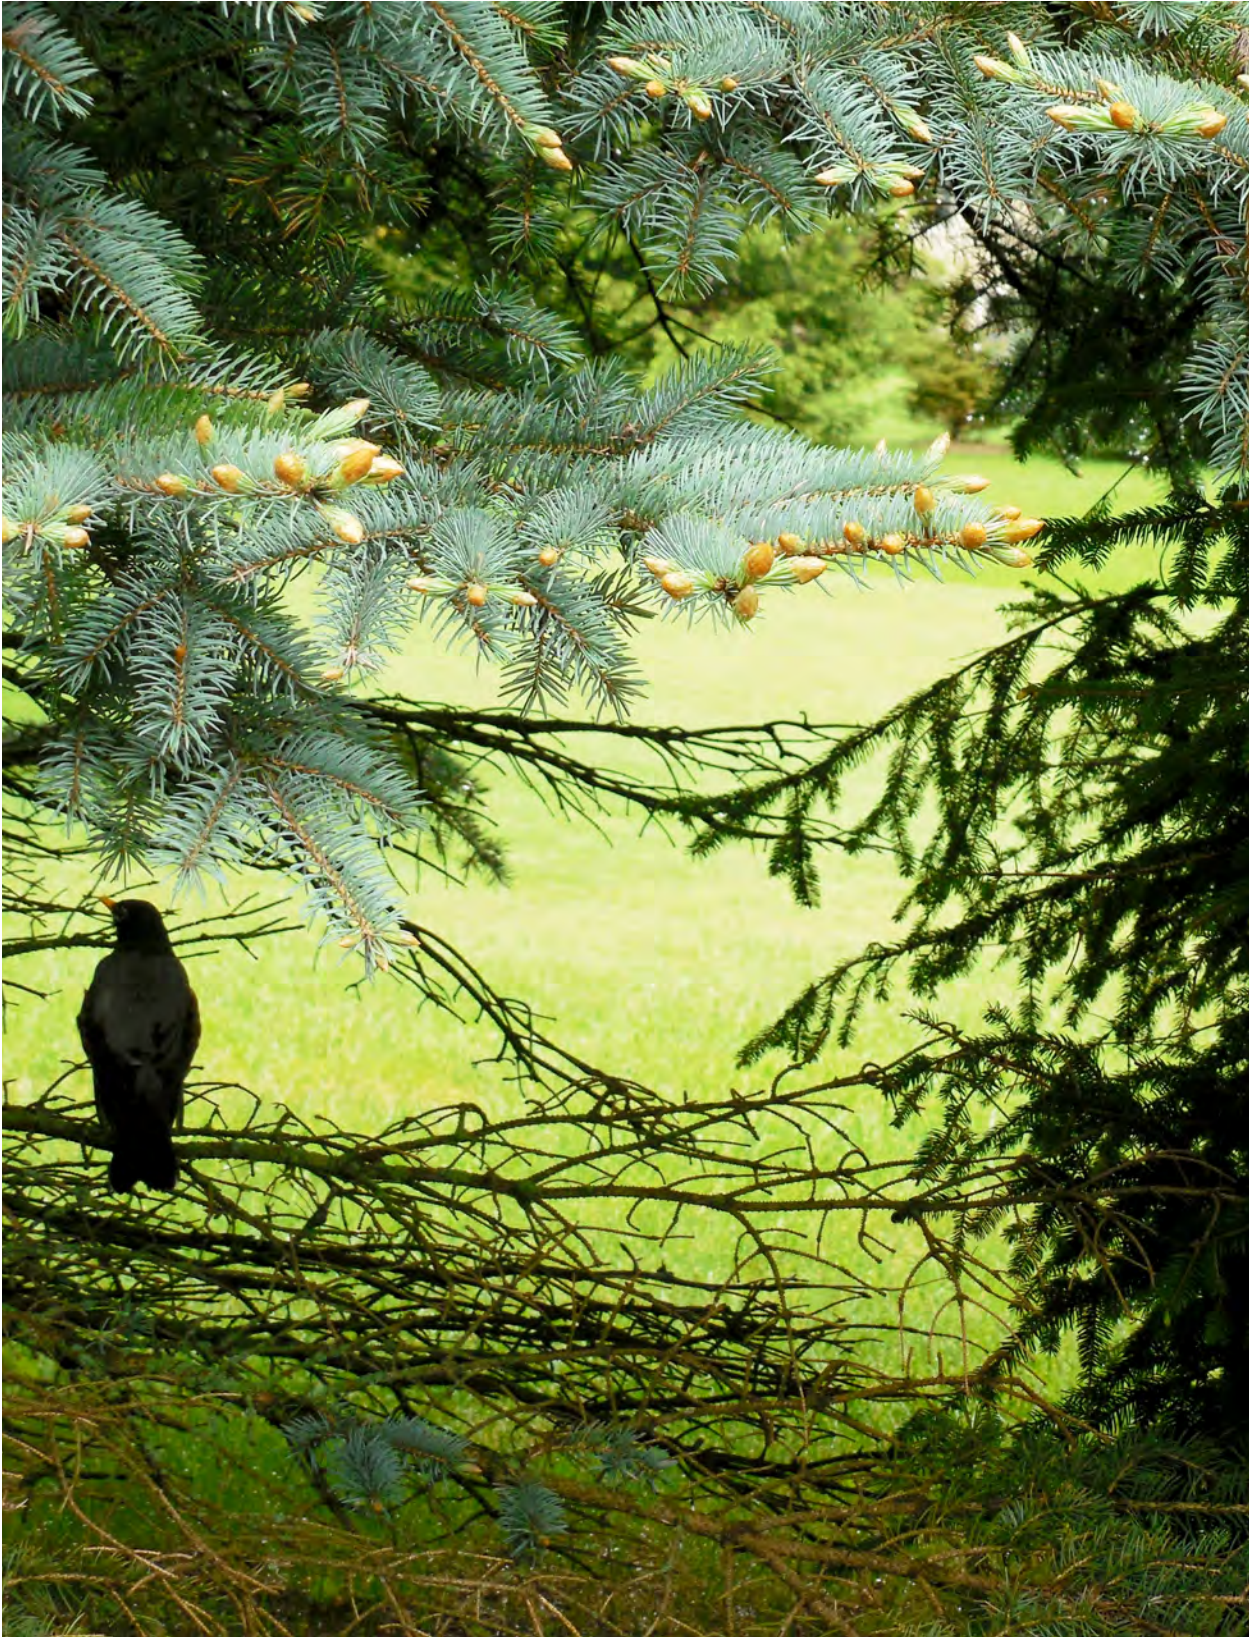
Figure 6. Transit Network

Within the Village, the principal transit routes are located on Canboro Road and Balfour Street. Four transit stops are located within the Village at Centennial Park, Fenwick Library, Canboro Road at Balfour Street, and Balfour Street at Alder Crescent. (Refer to Figure 6. Transit Network).

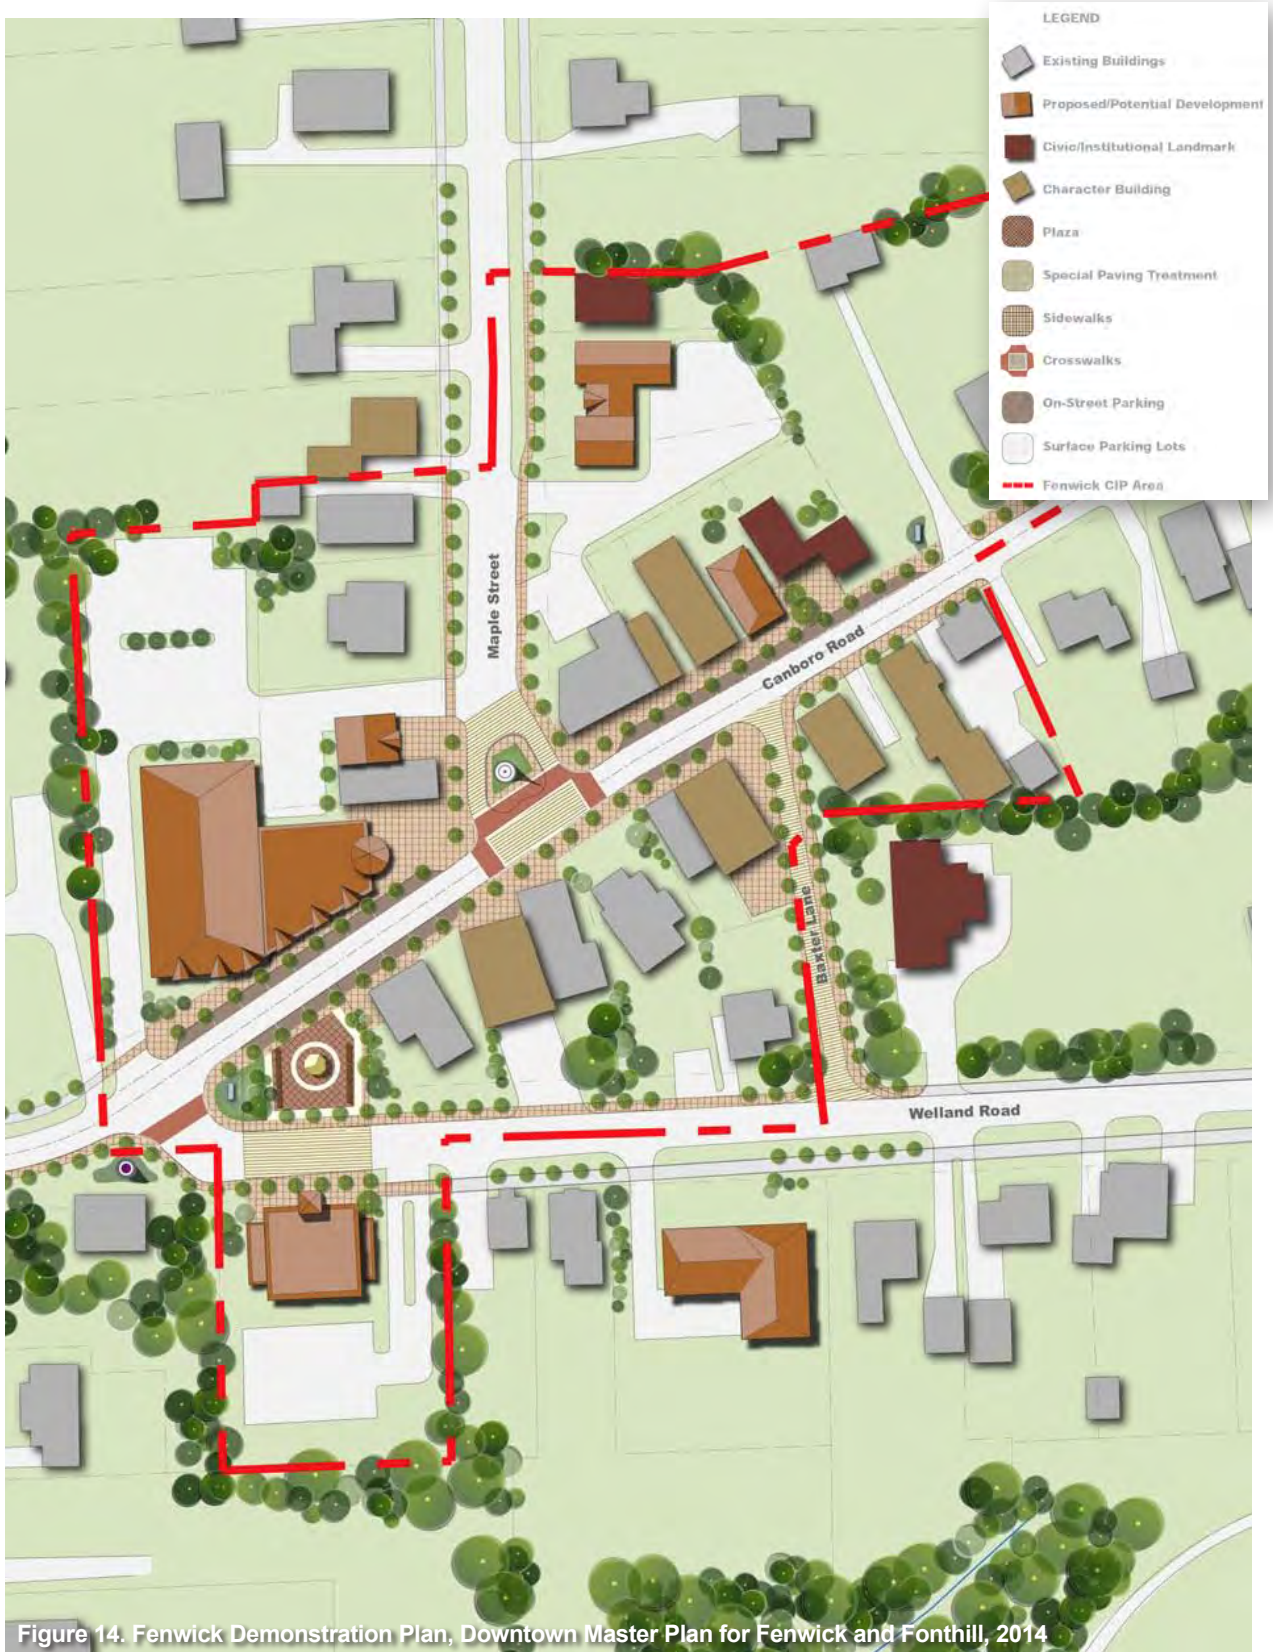
Overall, the Downtown Fenwick area is envisioned to establish a public plaza for community events and gatherings at the intersection of Canboro Road and Welland Road, with a clear focal point feature; create more comfortable streetscapes through widening sidewalks; and establishing special architectural features and public art at terminuses of view corridors (**Refer to Figure 14. Fenwick Demonstration Plan, Downtown Master Plan for Fenwick and Fonthill, 2014**).

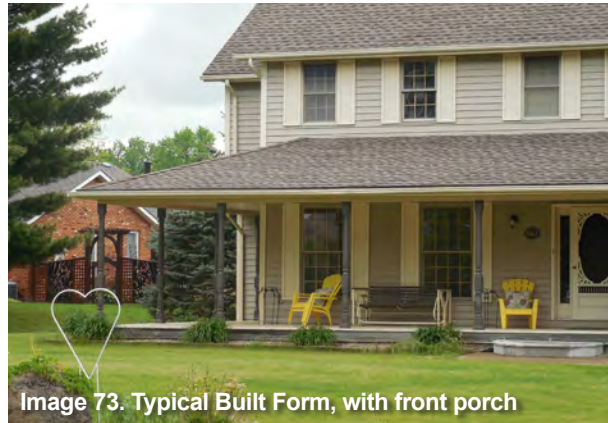
Image 73. Typical Built Form, with front porch

- Clear, direct, and unobstructed front entrances;
- Generous front lawns along existing bounding roads;
- Garages that are located at the back of buildings or set back from the buildings' front main entrances to minimize their impact on the streetscape; and,
- A two to four storey built form.

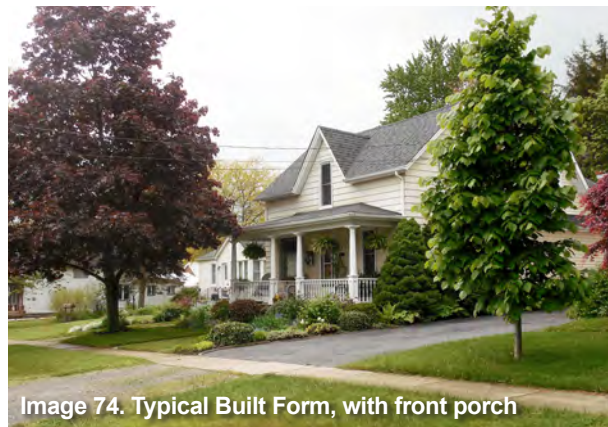
Image 74. Typical Built Form, with front porch

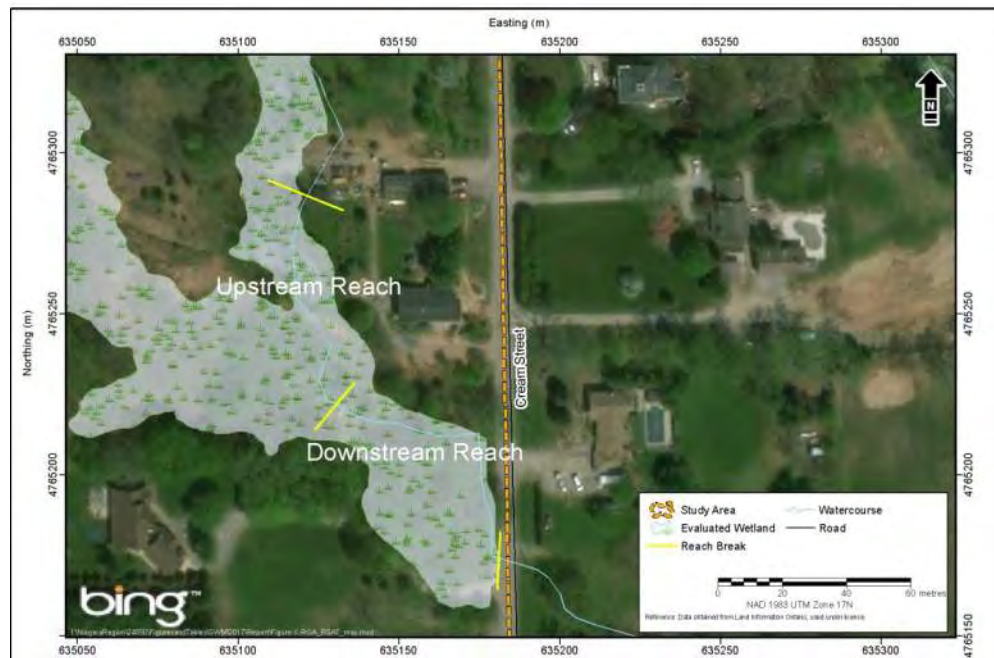
FIGURE 3.6 Reach Breaks for RGA/RSAT Assessment

A geomorphic assessment was conducted on the only accessible flowing watercourse in the Study Area, following the Rapid Stream Assessment Technique (RSAT) and Rapid Geomorphic Assessment (RGA) protocols. The unnamed watercourse crossing Cream Street was divided into two reaches based on distinct changes in the physical characteristics of the channel. The limits of each reach (upstream and downstream) are shown on Figure 3.6.

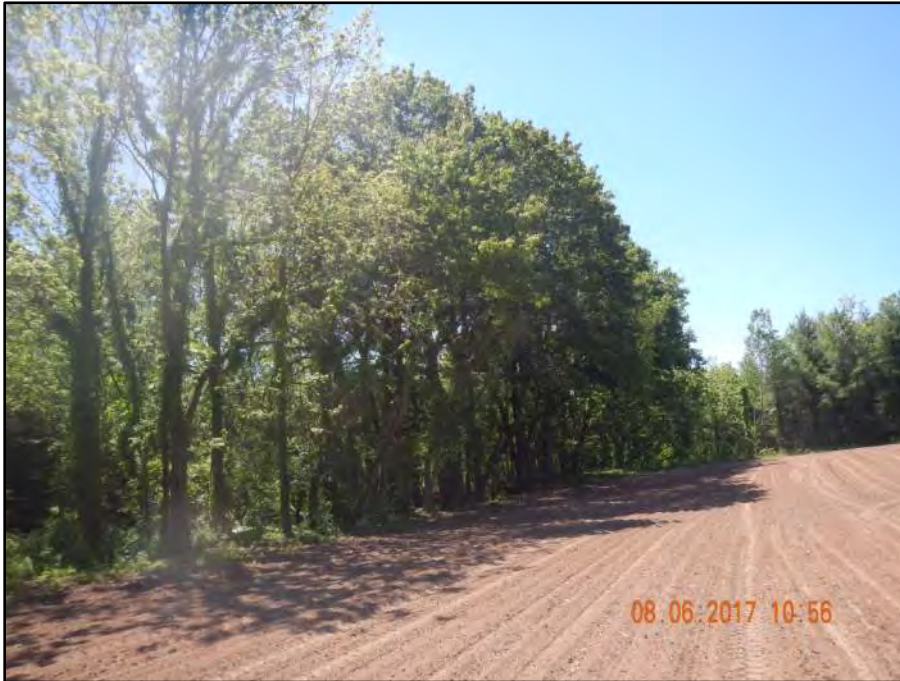
1. Mature hedgerow with trees ranging in DBH from 50 to 110 cm

The largest mature trees were located in hedgerows and on the edge of woodland units in proximity to existing agricultural fields and cleared land (Appendix B, photograph 1). Species recorded reaching mature size include Northern Red Oak (*Quercus rubra*), White Pine (*Pinus strobus*), Sugar Maple (*Acer saccharum*), Black Cherry (*Prunus serotina*) and Hickory (*Carya sp.*; Appendix B, photographs 7 and 8). Clusters or groves of mature trees were also found within the larger woodland units. These groupings displayed a greater diversity in age range (individuals of several species present from seedlings in the understory through to mature canopy) compared to the remainder of the woodland. Mature trees (individuals and clusters) observed in the Study Area are presented on Figure 3.3

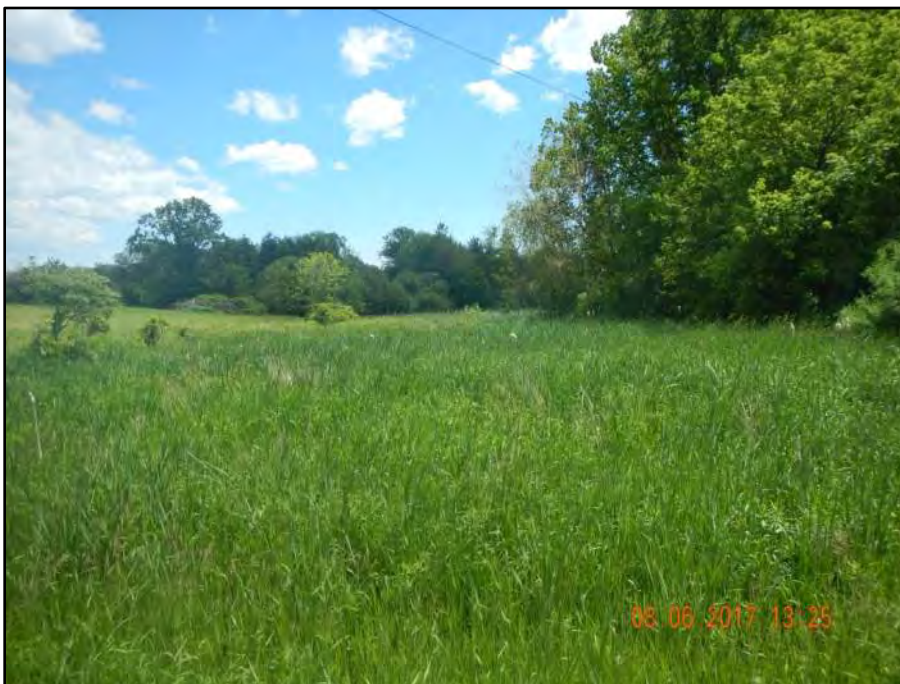
2. Wetland immediately south of Canboro Road.

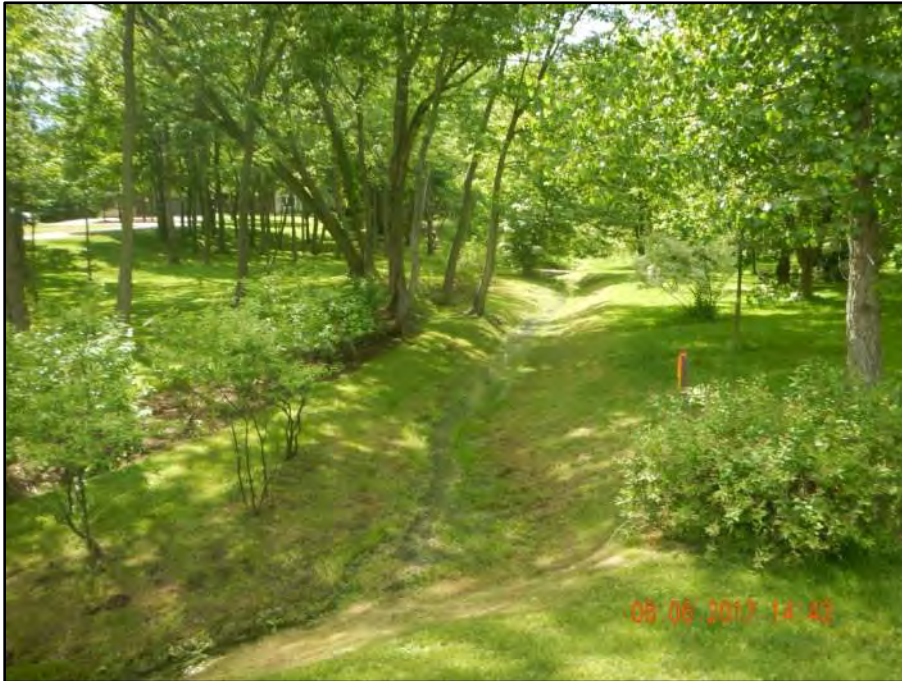
3. Reach 1 between properties- ditch like with no riparian vegetation.

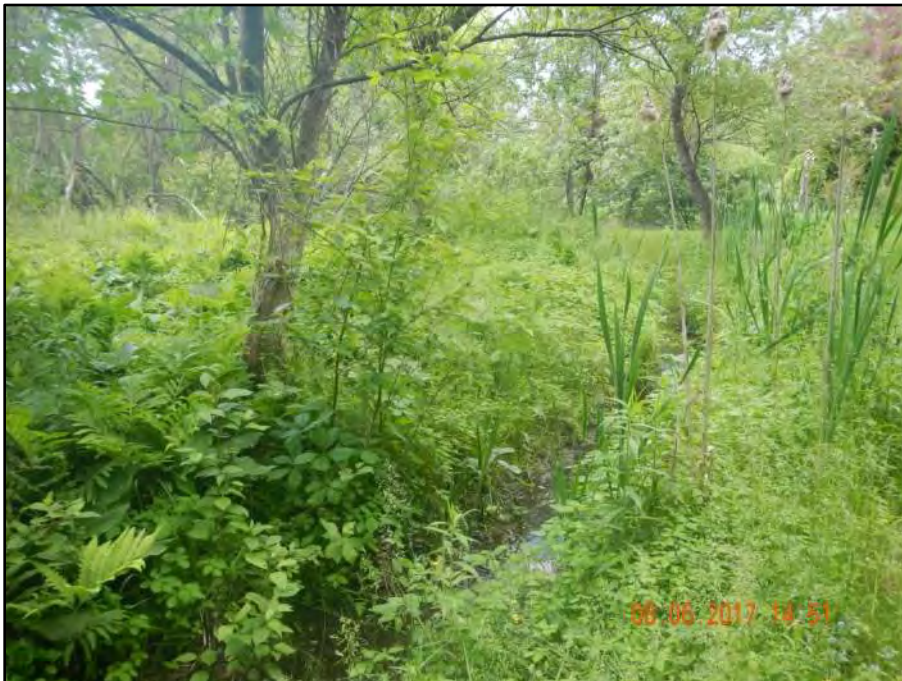
4. Reach 2 displaying large quantities of riparian vegetation.

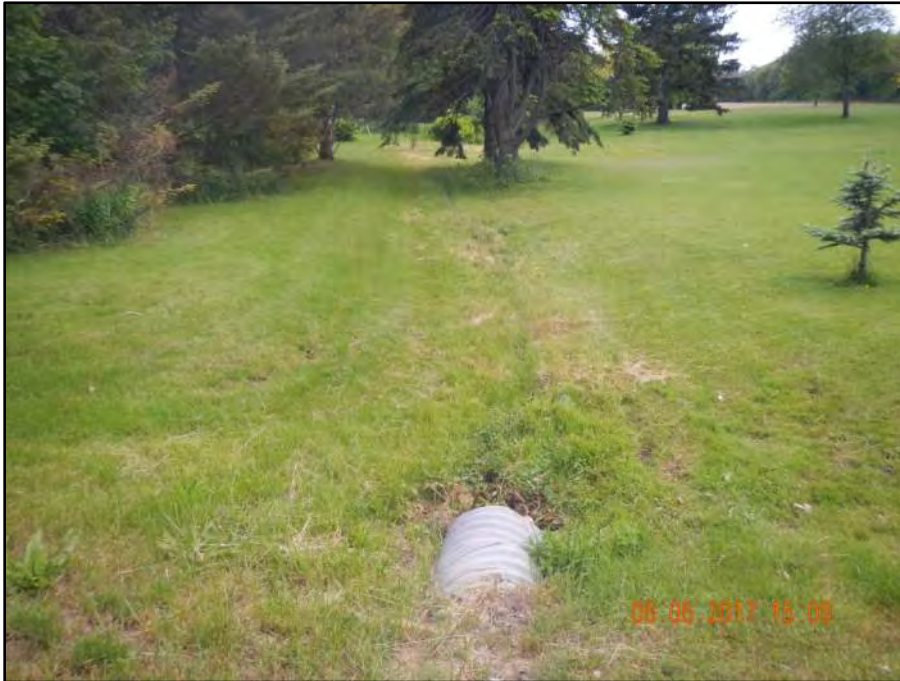
5. Dry drainage feature downstream of Welland Road.

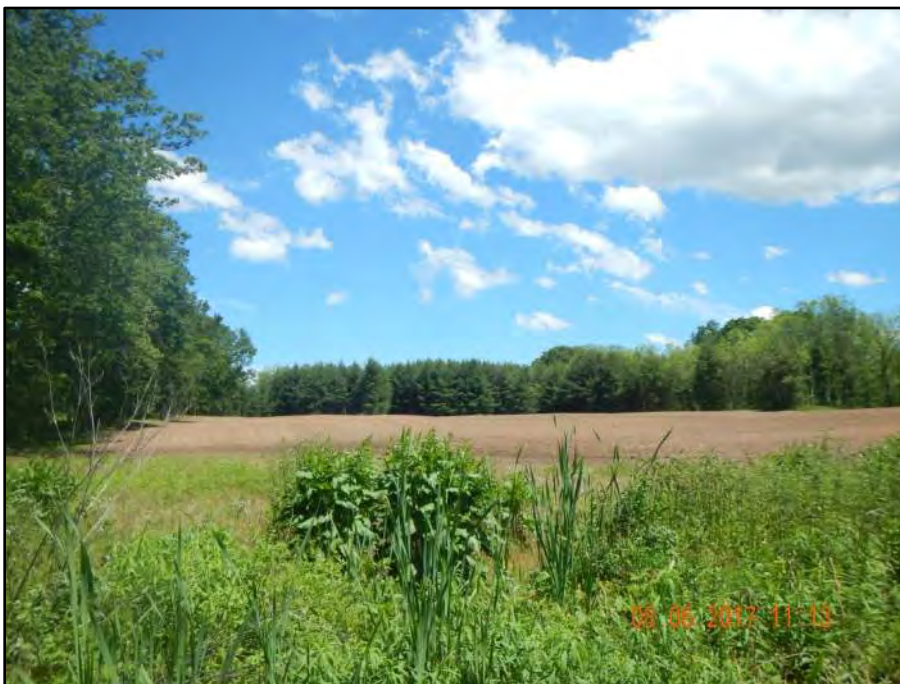
6. View of agricultural field showing no evidence of drainage feature during time of assessment.

Five aquatic habitat assessments were completed on intermittent drainage features crossing Welland Road. Two drainage features originated from agricultural fields (Appendix B, photograph 6), two originated from residential lots, and one originated from a woodland unit. Four were dry swales (originating from a residential lot and agricultural fields; Appendix B, photograph 5) lined with mowed grass and lacked riparian vegetation, variable substrate composition, woody debris, or signs of possible depth variability when water is present. These features have a low aquatic habitat potential. The most easterly drainage feature along Welland Road (originating from both a residential and a woodland unit) did contain approximately 8 cm of standing water. This feature was undefined, highly vegetated, and quickly merged with a marshy area after exiting the culvert crossing. This drainage feature is considered to have low habitat potential.

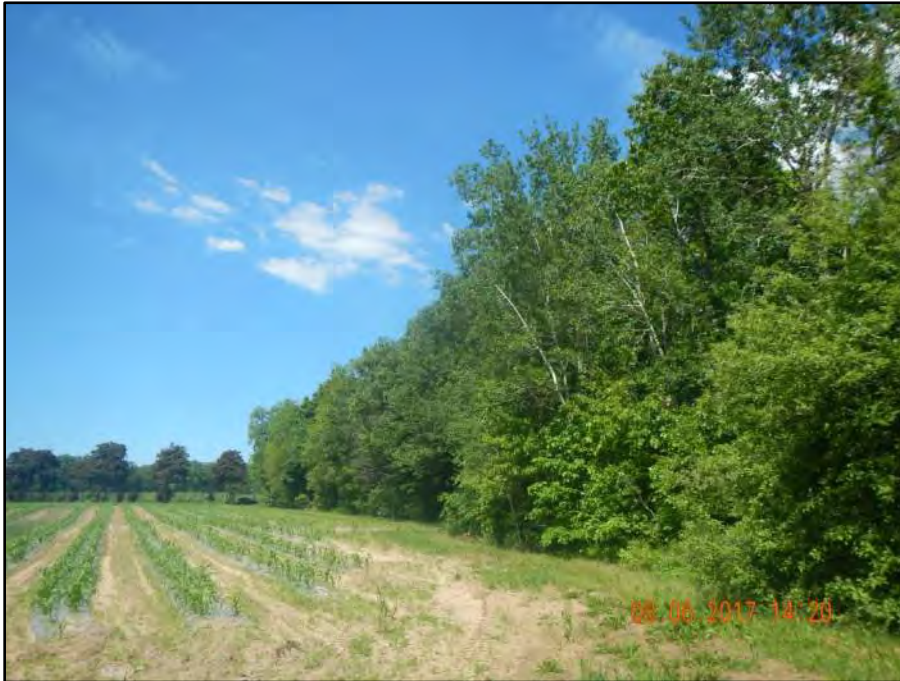
7. Mature hedgerow with Hickory species present.

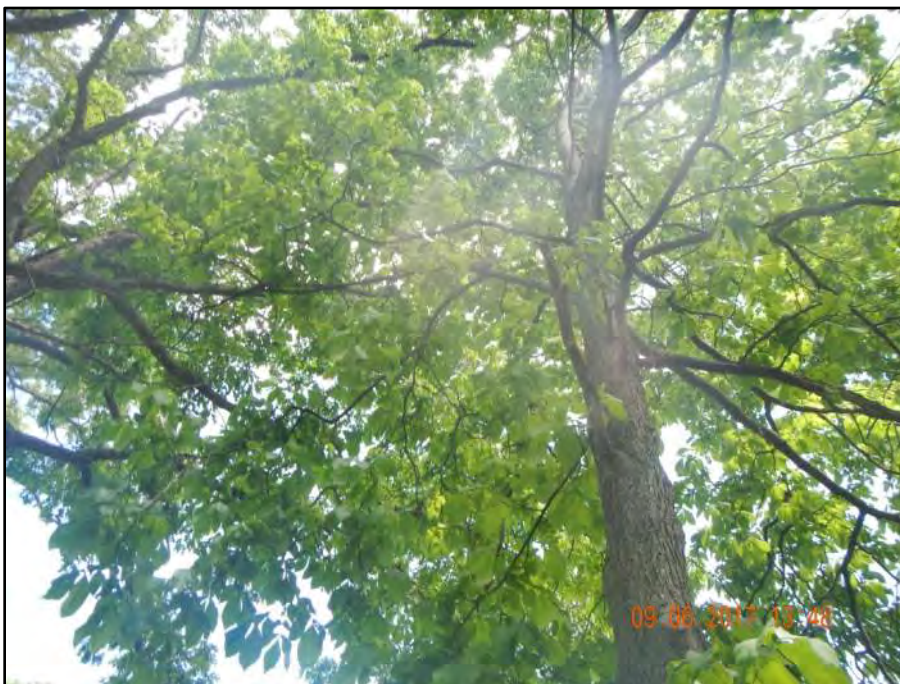
8. Hickory species in mature hedgerow.

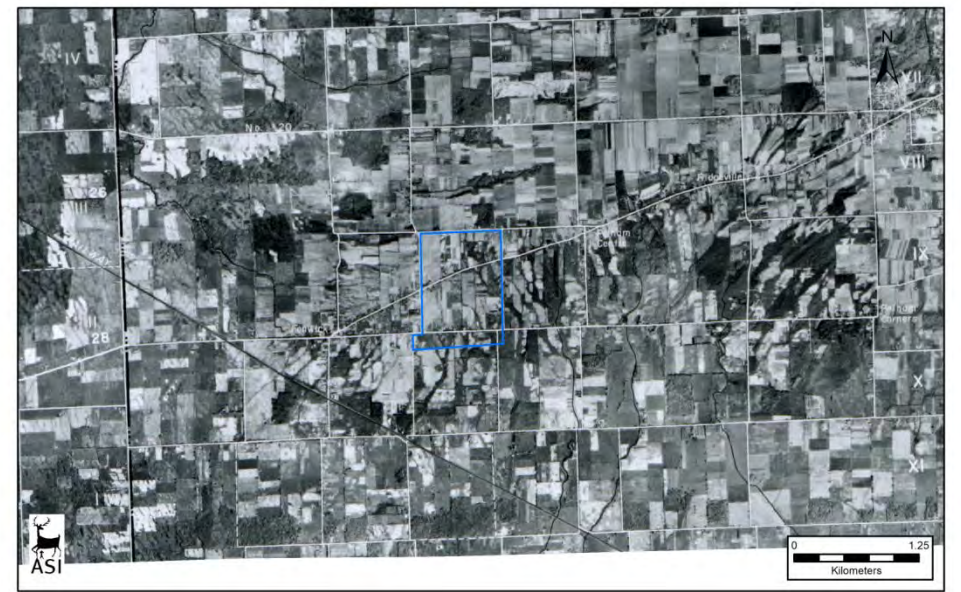
Figure 7: 1954 Aerial Photograph
 (Source: Hunting Survey Corporation 1954)

In the Digital Aerial Photograph of Southern Ontario from 1954 (Figure 7), the area retains its rural agricultural character. Very little development has occurred beyond the historic agricultural and rural hamlet historic settlement patterns of Fenwick.

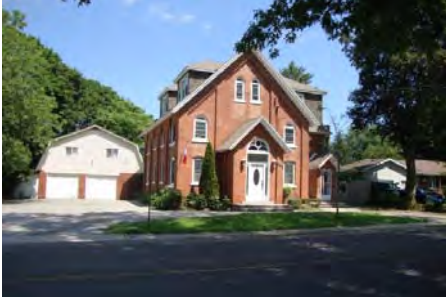
BHR 2	655 Canboro Rd.	Listed	Residential, farmscape	<p>Design: Built in 1872. A two-storey, red brick Gothic Revival-style residential building with a front gable roof. A central front gable frames a single second-storey door. The first storey features two tall round-headed 2-over-2 sash windows and an off-centre entry, covered by a central porch supported by flattened columns. Bargeboard decorates the front gable and porch eaves. A garage is located to the west of the house. The property is set well back from the road and has a maintained lawn, mature plantings and an established entrance drive. The property also contains a large field behind the house.</p> <p>History: This property is identified as belonging to George Waters in the 1862 Tremaine’s Map. C. Reece is identified as the property owner in the 1880 Historical Atlas map.</p> <p>Context: Located adjacent to the Canboro Rd. CHL.</p>

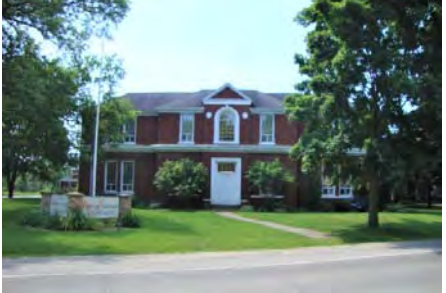
BHR 3	704 Canboro Rd.	Listed	School, converted into apartment building	<p>Design: A two-storey red brick Edwardian-style school building built in 1927. The symmetrical, stepped façade features a projecting centre bay with quoining. The frontispiece is topped by a pediment, with a semi-circular window with moulded trim on the second storey. The front door has a flat transom and moulded trim. The first and second storeys feature a moulded cornice and flat-headed windows. The building has long brick additions added in the mid-twentieth century on the west and south sides. The property features a maintained lawn with mature trees, a small parking lot at the front and a large rear parking lot.</p> <p>History: Built in 1927 as the Pelham Secondary School. Served as school from 1927-1974. It was then converted into an apartment building called the Canboro Gardens.</p> <p>This property is identified as belonging to James Garner in the 1862 Tremaine’s Map and in the 1880 Historical Atlas map. A building is identified as being in this location in the 1938 topographic map.</p> <p>Context: Located at the southwest corner of Canboro Rd. and Balfour St., this property is in a transition area between urban and rural boundaries. A subdivision is located to the northwest, while the other surrounding areas are largely rural/agricultural.</p>

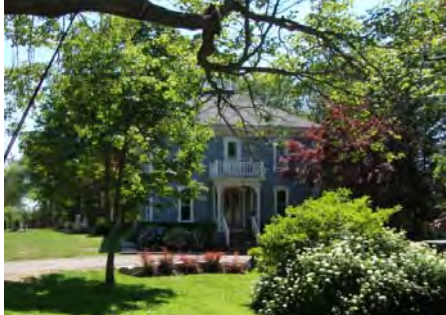
Table 4 Detailed description of built heritage resources (BHR) and cultural heritage landscapes (CHL) in the study area					
Feature ID	Address	Heritage Status	Resource Type	Description/Comments	Photograph(s)
BHR 4	1159 Cream St.	Listed	Residential	<p>Design: A two-storey Folk Victorian-style frame residential building clad in siding, built ca. 1870. The building features a rectangular floor plan and a symmetrical façade. The central entranceway has double doors framed by a portico and second storey balcony. The one-over-one sash windows have decorative trim. The cornice features brackets and a decorated soffit. A belvedere sits atop the hip roof. The property features a semi-circular driveway, a maintained lawn and numerous mature plantings.</p> <p>History: No property owner is identified in the 1862 Tremaine’s Map or in the 1880 Historical Atlas map, but a house is identified as being in this location in 1880.</p> <p>Johannes Groh (anglicized to John Crow) was a weaver who migrated from Pennsylvania in 1788 to settle in Pelham in with his wife and five children. His fifth child, Jacob Crow Sr., was a prosperous landowner who purchased this property in 1854, and it remained in the Crow family until 1914. The house (built ca. 1870) is recorded as the residence of Jacob’s nephew, William Crow, who lived there with his wife, Sarah Jane (Huntsman). Their son Alandis started canning produce on the property before establishing a canning factory at 410 Canboro Rd (later the site of Lindsay Lumber and now the site of the Ridgeville Post Office). William Crow’s cousin, John Bowman Crow (1821-1887), was a notable member of the Crow family who in 1859 was appointed clerk to the Township of Pelham. In 1883 he also took on the job of Township Treasurer. His son Judson C. Crow, who had been a schoolmaster, succeeded him in the post of clerk.</p> <p>Context: Located adjacent to the Canboro Rd. CHL.</p>

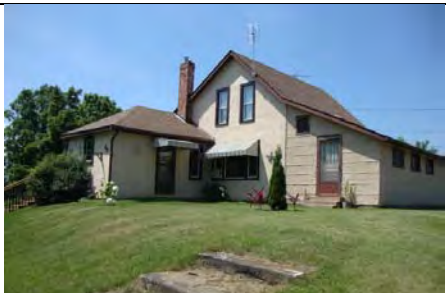
BHR 5	606 Canboro Rd.	Identified during field review	Residential	<p>Design: A 1.5-storey, L-shaped stucco residential cottage with a side addition, likely built prior to 1880. The building has gable and hip roofs, an off-centre entrance, a brick chimney and flat-headed windows. It is located atop a berm at the corner of Cream St. and Canboro Rd., with a driveway accessible from both roads. The property has a maintained lawn and mature trees.</p> <p>History: No property owner is identified in the 1862 Tremaine’s Map. “Mrs. B.” is identified as the property owner in the 1880 Historical Atlas map. A house is identified as being in this location in 1880.</p> <p>Context: Located adjacent to the Canboro Rd. CHL., at the southwest corner of Canboro Rd. and Cream St.</p>

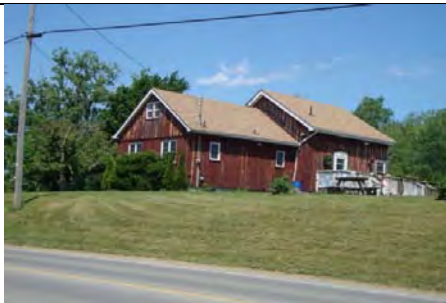
BHR 6	607 Canboro Rd.	Identified during field review	Residential	<p>Design: A 1.5-storey frame residential building with board and batten siding, likely built prior to 1880. The building consists of two rectangular plans of similar size joined end to end with, with side gable roofs and flat-headed windows. The house is located atop a berm, with a maintained lawn, mature trees, and a driveway exiting onto Cream St.</p> <p>History: No property owner is identified in the 1862 Tremaine’s Map or the 1880 Historical Atlas map. A house is identified as being in this location in 1880.</p> <p>Context: Located adjacent to the Canboro Rd. CHL., at the northwest corner of Canboro Rd. and Cream St.</p>

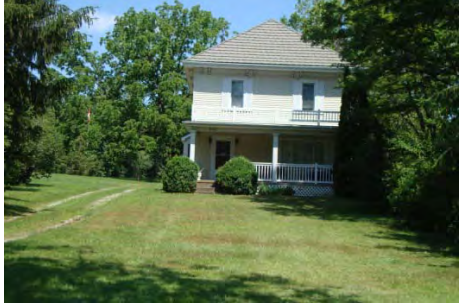
Feature ID	Address	Heritage Status	Resource Type	Description/Comments	Photograph(s)
BHR 8	645 Canboro Rd.	Identified during field review	Residential, farmscape	<p>Design: A two-storey, frame residential building with a hip roof and a rectangular floorplan, likely built prior to 1880. A front porch is topped with a balcony and two symmetrical flat-headed windows with shutters on the second-storey. Paired wooden brackets are featured along the cornice. Outbuildings are located to the north and northwest of the house. The property has a maintained lawn, mature trees, an established entrance drive and farm fields.</p> <p>History: This property is identified as belonging to “T.C.” in the 1862 Tremaine’s Map. No property owner is identified in the 1880 Historical Atlas map. A house is identified as being in this location in 1880.</p> <p>Context: Located adjacent to the Canboro Rd. CHL. The property appears to be an active farmscape, with fields located to the east and north of the house and possible agricultural buildings located behind the house.</p>

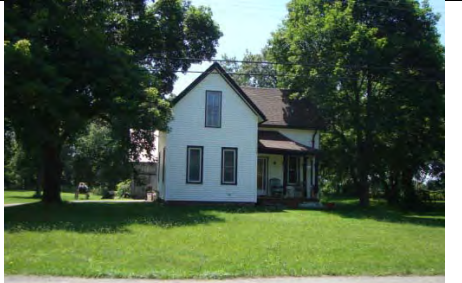
BHR 9	668 Canboro Rd.	Identified during field review	Residential	<p>Design: A 1.5-storey, frame residential building with an L-shaped plan, likely built prior to 1880. The building has flat-headed windows and a cross gable roof. The entryway features a small porch with a bell-curved roof. Small setback. An outbuilding is located directly behind the house. The property has a maintained lawn, mature trees and an established entrance drive.</p> <p>History: This property is identified as belonging to J. Hicks in the 1862 Tremaine’s Map. George Cplar is identified as the property owner in the 1880 Historical Atlas map. A house and orchard are identified as being in this location in 1880.</p> <p>Context: Located adjacent to the Canboro Rd. CHL.</p>

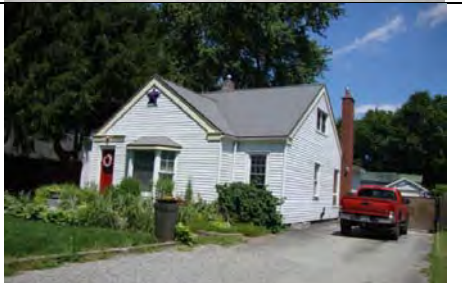
BHR 10	675 Canboro Rd.	Identified during field review	Residential	<p>Design: A 1.5-storey, frame residential building clad in aluminum siding with a cross gable roof and a rear addition, likely built between 1920 and 1938. The building has a front central gable, flat-headed windows, a central bay window and two brick chimneys. A garage and an outbuilding are located to the north of the house. The property has a maintained lawn, mature trees and an established entrance drive, with a small setback.</p> <p>History: This property is identified as belonging to George Waters in the 1862 Tremaine’s Map. C. Reece is identified as the property owner in the 1880 Historical Atlas map.</p> <p>Context: Located adjacent to the Canboro Rd. CHL.</p>

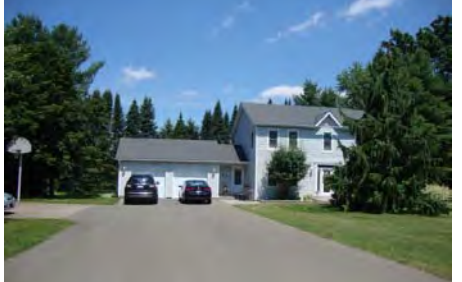
BHR 11	687 Canboro Rd.	Identified during field review	Residential	<p>Design: A two-storey, frame residential building clad in vinyl siding with a side gable roof, rectangular floorplan and symmetrical façade, likely built between 1907 and 1920. The building features a central entranceway with a transom, sidelights and pilasters, flanked by flat-headed windows. A garage has been added to the west side of the house. The property has a maintained lawn, mature trees and an established entrance drive.</p> <p>History: This property is identified as belonging to “E.M.” in the 1862 Tremaine’s Map. R. Farr is identified as the property owner in the 1880 Historical Atlas map.</p> <p>Context: Located adjacent to the Canboro Rd. CHL.</p>

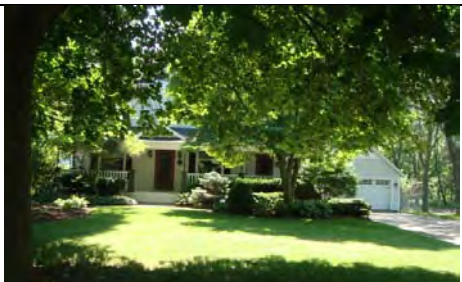
BHR 12	688 Canboro Rd.	Identified during field review	Residential	<p>Design: A two-storey frame residential building clad in siding, likely built prior to 1880. The building has a verandah with a central pediment, decorative turned posts and decorative moulding along the verandah roofline. A garage is located to the east of the house. The property has a maintained lawn, mature trees and an established entrance drive.</p> <p>History: This property is identified as belonging to R. Farr in the 1862 Tremaine’s Map and in the 1880 Historical Atlas map. A house and an orchard are identified as being in this location in 1880.</p> <p>Context: Located adjacent to the Canboro Rd. CHL.</p>

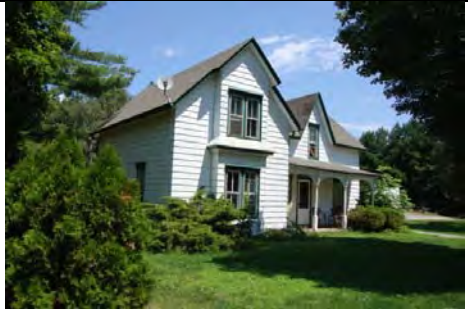
Table 4 Detailed description of built heritage resources (BHR) and cultural heritage landscapes (CHL) in the study area					
Feature ID	Address	Heritage Status	Resource Type	Description/Comments	Photograph(s)
BHR 13	691 Canboro Rd.	Identified during field review	Residential	<p>Design: A 1.5-storey frame residential building clad in vinyl siding, with a rear addition, likely built between 1920 and 1938. The building has an L-shaped floorplan with cross gable roofs and stacked oriel windows. The entranceway is covered by a porch with a bell-curved roof, and a gable is centred over the porch. The porch features bargeboard and is supported by turned posts. The 2-over-2 sash windows are flat-headed. A large barn is located east of the house and is connected by the semi-circular driveway. The property has a maintained lawn and mature trees.</p> <p>History: This property is identified as belonging to R. Farr in the 1862 Tremaine’s Map and in the 1880 Historical Atlas map.</p> <p>Context: Located adjacent to the Canboro Rd. CHL.</p>

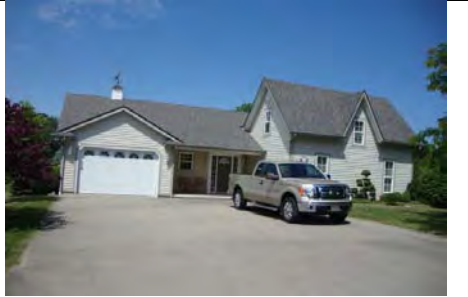
BHR 14	1108 Cream St.	Identified during field review	Residential	<p>Design: A 1.5-storey frame residential cottage built c. 1879. Clad in siding, with a large single storey addition on the south side. The original cottage features a symmetrical facade with a side gable roof, a pointed central gable and flat-headed windows. The property has a maintained lawn, mature trees and an established entrance drive.</p> <p>History: Rason Cottage. This property is identified as belonging to J. Crow in the 1862 Tremaine’s Map. No property owner is identified in the 1880 Historical Atlas map. A house is identified as being in this location in 1880.</p> <p>Context: The property is located on Cream St., which is largely comprised of residential properties set back from the road within a rural/agricultural area.</p>

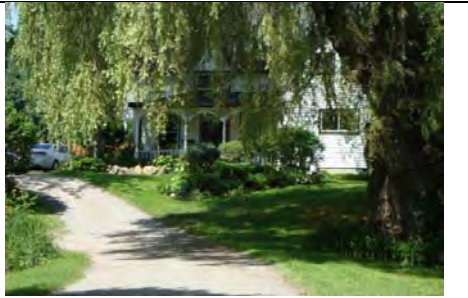
BHR 15	1118 Cream St.	Identified during field review	Residential	<p>Design: A 1.5 storey, Victorian frame residential building clad in siding with an L-shaped floorplan, likely built prior to 1880. The building has cross gable roofs, flat-headed windows and a porch decorated with bargeboard and supported by turned posts. The property has a maintained lawn, mature trees and an established entrance drive with a large setback.</p> <p>History: This property is identified as belonging to J. Crow in the 1862 Tremaine’s Map. “B.F.” is identified as the property owner in the 1880 Historical Atlas map. A house is identified as being in this location in 1880.</p> <p>Context: The property is located on Cream St., which is largely comprised of residential properties set back from the road within a rural/agricultural area.</p>

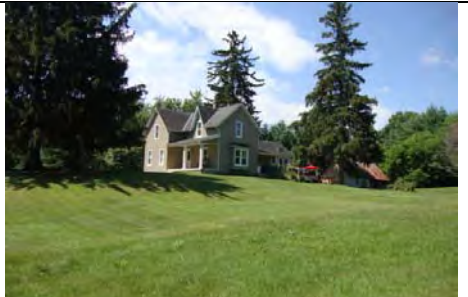
BHR 16	1128 Cream St.	Identified during field review	Residential	<p>Design: A 1.5-storey, frame residential building clad in siding, likely built prior to 1880. The building has a T-shaped floorplan with a cross gable roof and flat-headed windows. The entranceway is covered by a porch, and a pointed gable is centred over the porch. The property has a maintained lawn, mature trees and an established entrance drive, with a large setback.</p> <p>History: This property is identified as belonging to J. Crow in the 1862 Tremaine’s Map. “J.S.” is identified as the property owner in the 1880 Historical Atlas map. A house is identified as being in this location in 1880.</p> <p>Context: The property is located on Cream St., which is largely comprised of residential properties set back from the road within a rural/agricultural area.</p>

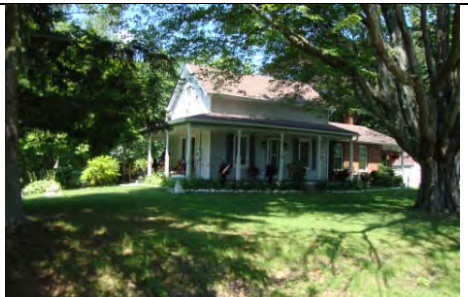
BHR 17	1162 Cream St.	Identified during field review	Residential	<p>Design: A 1.5-storey frame residential building clad in siding with a brick-clad addition on the north side, likely built prior to 1880. The building has a rectangular floorplan and symmetrical façade, with a central entranceway flanked by flat-headed windows, a side gable roof and an open verandah supported by turned posts. A shed is located to the north of the house. The property has a maintained lawn, mature plantings and an established entrance drive.</p> <p>History: No property owner is identified in the 1862 Tremaine’s Map or the 1880 Historical Atlas map. A house is identified as being in this location in 1880.</p> <p>Context: The property is located on Cream St., which is largely comprised of residential properties set back from the road within a rural/agricultural area.</p>

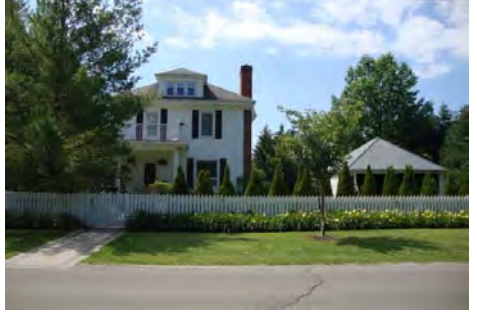
Feature ID	Address	Heritage Status	Resource Type	Description/Comments	Photograph(s)
BHR 18	578 Welland Rd.	Identified during field review	Residential	<p>Design: A 2-storey frame residential building clad in siding with a square floorplan, a hip roof and an external brick chimney, likely built between 1920 and 1938. The asymmetrical façade features a portico supported by columns, a second-storey balcony, and a gabled dormer. The flat-headed windows have shutters. A garage is located to the east of the house. The property has a maintained lawn, a picket fence, mature plantings and an established entrance drive.</p> <p>History: This property is identified as belonging to J. F. Stitzinger in the 1862 Tremaine’s Map and in the 1880 Historical Atlas map.</p> <p>Context: The property is located near the corner of Cream St. on Welland Rd., which is largely comprised of residential properties and agricultural land.</p>

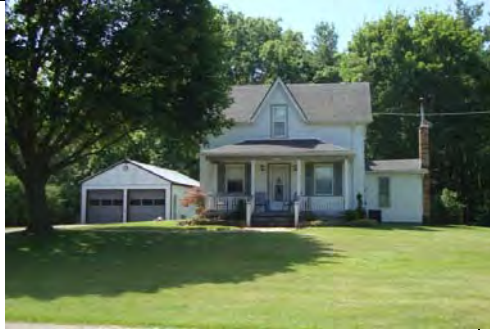
BHR 19	630 Welland Rd.	Identified during field review	Residential	<p>Design: A 1.5-storey frame residential building clad in siding, with a single-storey extension on the west side, likely built prior to 1862. The building features a rectangular floor plan and a symmetrical façade. The central entranceway is flanked by flat-headed windows with shutters. The side gable roof features a central gable, and a second-storey window is centred above a porch with a bell-curve roof. A garage is located to the east of the house. The property has a maintained lawn, mature trees and an established entrance drive.</p> <p>History: No property owner is identified in the 1862 Tremaine’s Map. A house is identified in this location in 1862. T. Scanton is identified as the property owner in the 1880 Historical Atlas map.</p> <p>Context: The property is located on Welland Rd., which is largely comprised of residential properties and agricultural land.</p>

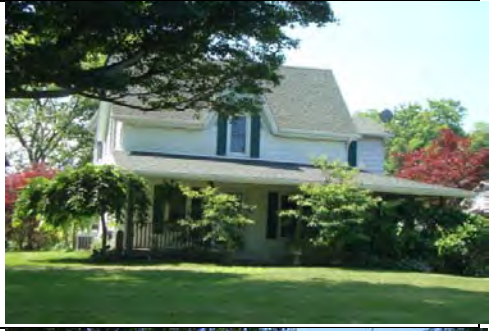
BHR 20	646 Welland Rd.	Identified during field review	Residential, farmscape	<p>Design: A 1.5-storey frame residential building clad in vinyl siding, with a large addition at the rear, likely built prior to 1862. The building features a symmetrical façade with a porch. The side gable roof has a central gable and the central entranceway is flanked by flat-headed windows with shutters. The property has a maintained lawn, mature trees and an established entrance drive. The property contains a field behind the house.</p> <p>History: This property is identified as belonging to U. Rice in the 1862 Tremaine’s Map. A house is identified as being in this location in 1862. D. Leppert is identified as the property owner in the 1880 Historical Atlas map.</p> <p>Context: The property is located on Welland Rd., which is largely comprised of residential properties and agricultural land.</p>

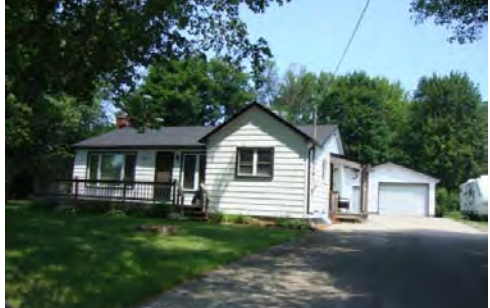
BHR 21	663 Welland Rd.	Identified during field review	Residential	<p>Design: A one-storey, frame residential building clad in vinyl siding, likely built between 1920 and 1938. The L-shaped floorplan has a cross gable roof. The asymmetrical façade features flat-headed windows. A garage is located northeast of the house. The property has a maintained lawn, mature trees and an established entrance drive.</p> <p>History: This property is identified as belonging to R. Farr in the 1862 Tremaine’s Map and in the 1880 Historical Atlas map.</p> <p>Context: The property is located on Welland Rd., which is largely comprised of residential properties and agricultural land.</p>
