TOWN OF PELHAM

EAST FENWICK SECONDARY PLAN BACKGROUND REPORT FINAL

SGL Planning & Design | ASI | AE | Matrix Solutions

Town of Pelham
JANUARY 26, 2018 - FINAL

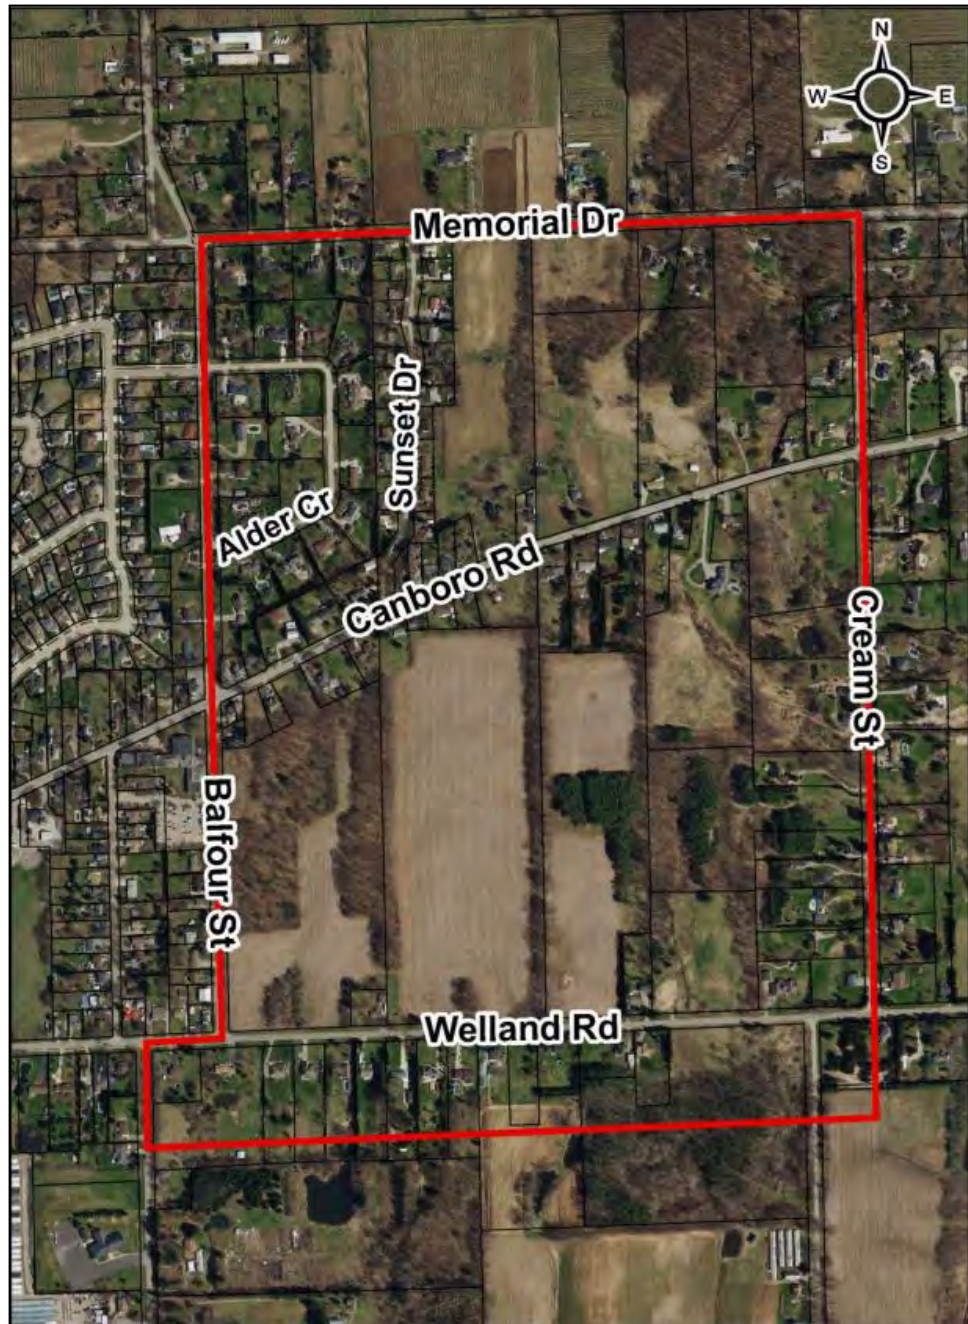
Figure 1-1
Study Area

The East Fenwick Secondary Plan is a proposed residential development that will provide housing for full-time residents within the Town of Pelham in a neighbourhood marked by sustainable transportation infrastructure through the implementation of bike lanes, sidewalks, and multi-use paths. The proposed development is situated immediately east of the community of Fenwick in an rural area bounded by Memorial Drive to the north, Cream Street to the east, Welland Road to the south, and Balfour Road to the west. The study area is presented in **Figure 1-1**.

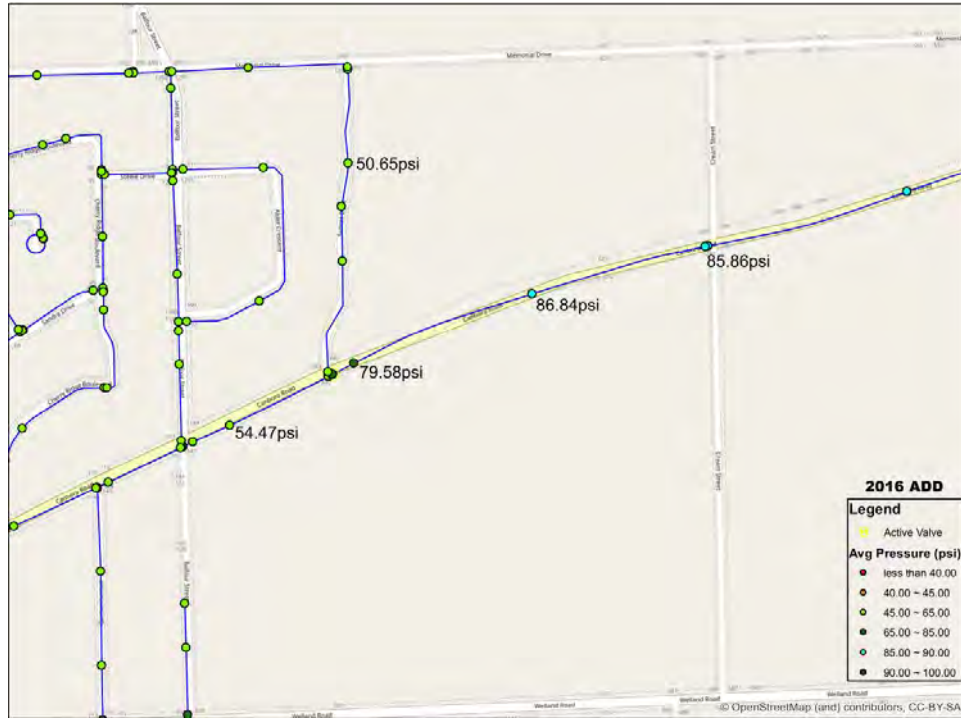
Figure 3-3: 2016 ADD Junction Pressures

The existing model provided for this analysis had current (2016) ADD and MDD scenarios set up based on the 2014 SCADA data. Both of these scenarios were run to determine the existing system pressures. The pressures within the study area are adequate during both ADD and MDD, as shown below in Figure 3-3 and Figure 3-4, respectively. As stated in the design criteria, the allowable residual system pressure is between 40 psi and 100 psi, with the preferable residual system pressure being between 50 psi and 70 psi. Pressure along Canboro Road, although still within the allowable pressure range, are above the preferable pressure range. As mentioned above, a PRV is located on Canboro Road at Sunset Drive to reduce pressures from above 80 psi to 53 psi, which is within the preferable pressure range.

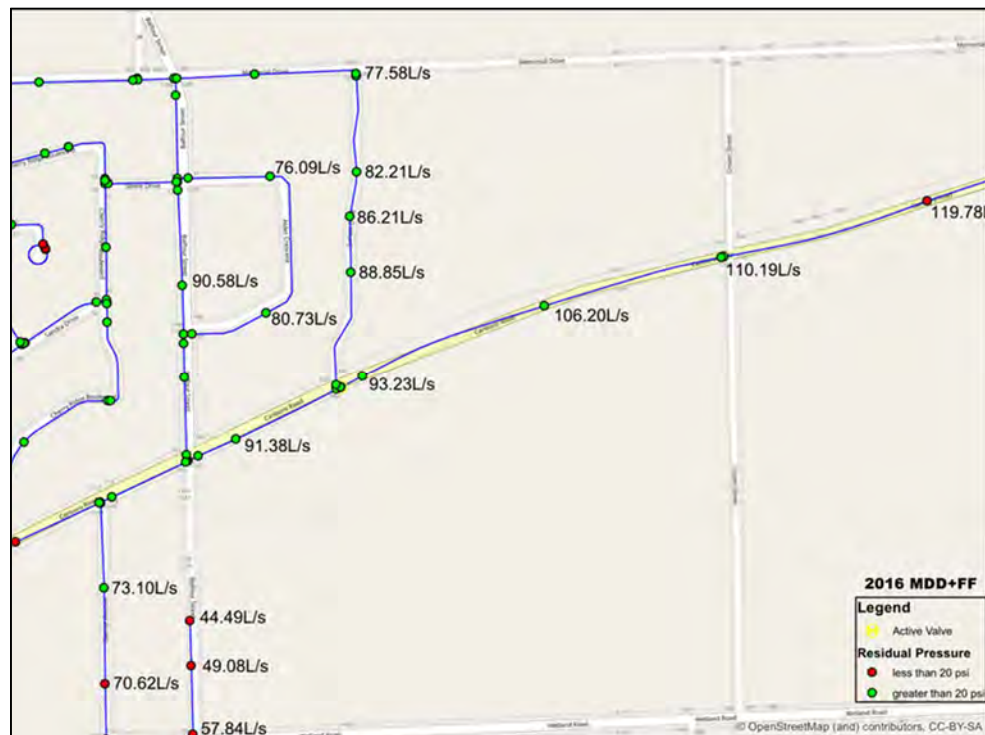
Figure 3-5: Fireflow Availability

A fireflow scenario was run using the MDD demand set. In the given model, the required fireflow controls at each node was set to 75 L/s, which is slightly higher than the City of Welland's 67.7 L/s fireflow requirement for single family and multi-density housing zones. During a MDD +FF scenario, the system pressures must be at or above 20 psi during fireflow. Figure 3-5 shows which nodes will remain at or above 20 psi in the event of a fire, and the available flow at each of the nodes. As shown in the figures, the majority of the nodes provide adequate pressure and flow. There are a minimum number of nodes unable to provide adequate fireflow and these nodes are located at deadends of 150 mm diameter mains. In order for these nodes to provide adequate flow, the main to the nodes would need to be a larger diameter or looped.

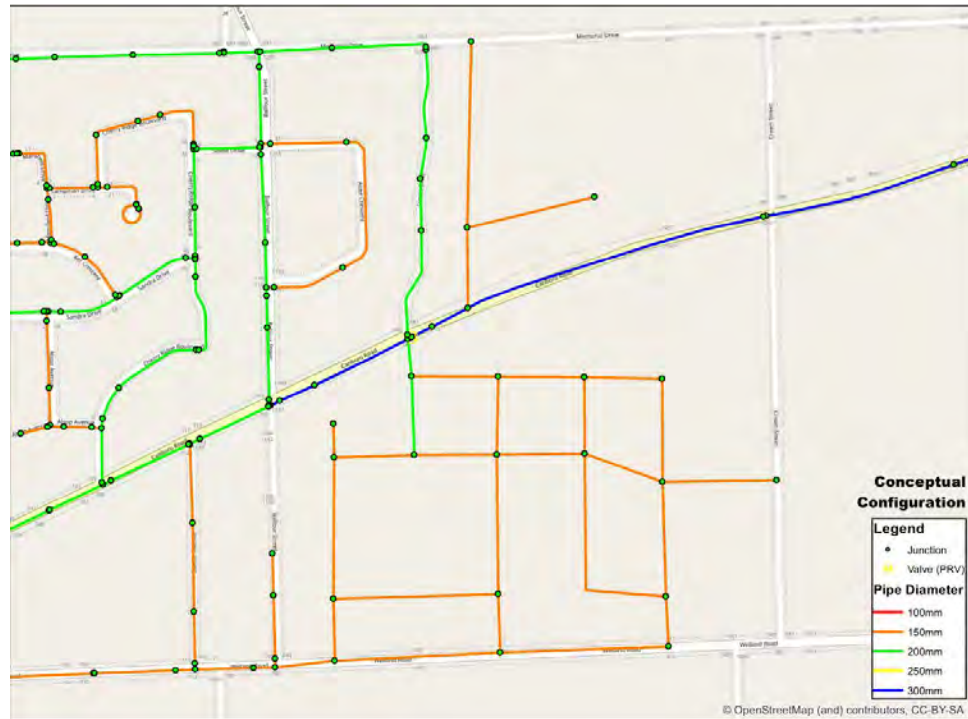
Figure 3-6: Conceptual Configuration of Watermains in Study Area

To determine if there is capacity available with the proposed development, the conceptual layout, population and demands from the Conceptual Tertiary Plan, which was part of the East Fenwick Secondary Plan Area created by Upper Canada Consultants in August 2010 was used. This conceptual plan is shown in Figure 3-6.

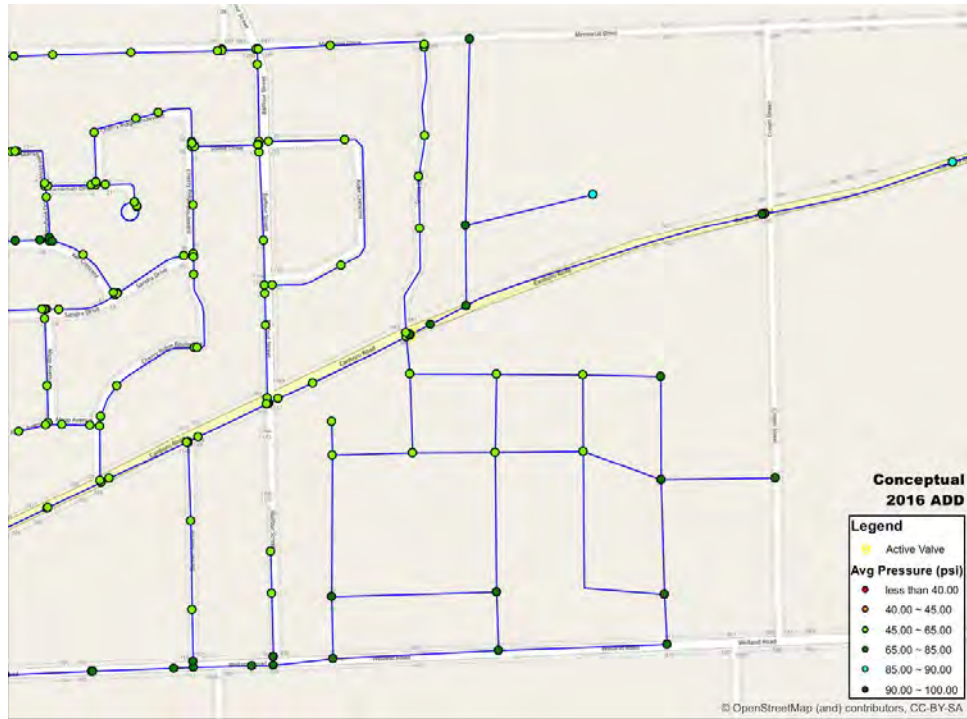
Figure 3-7: Conceptual 2016 ADD Junction Pressures

Child scenarios of the existing ADD and MDD scenarios were created and the conceptual development was added using the existing ground elevations for the nodes. These child scenarios were run to determine the available pressures within the new development area. As shown in Figure 3-7 and Figure 3-8, pressure in the proposed development are all within the allowable pressure range. Pressures in the development area to the north of Canboro Road, although within the allowable pressure range, are above the preferred pressure range. This is due to the fact that the connection is shown prior to the PRV where system pressures are above 80 psi. When designing the local watermain, all connections to the trunk main on Canboro Road must consider the PRV. Discussions should be had with the Region, during the detailed design stage, regarding moving the PRV further upstream, or the addition of PRV(s) at the connections for new local municipal mains.

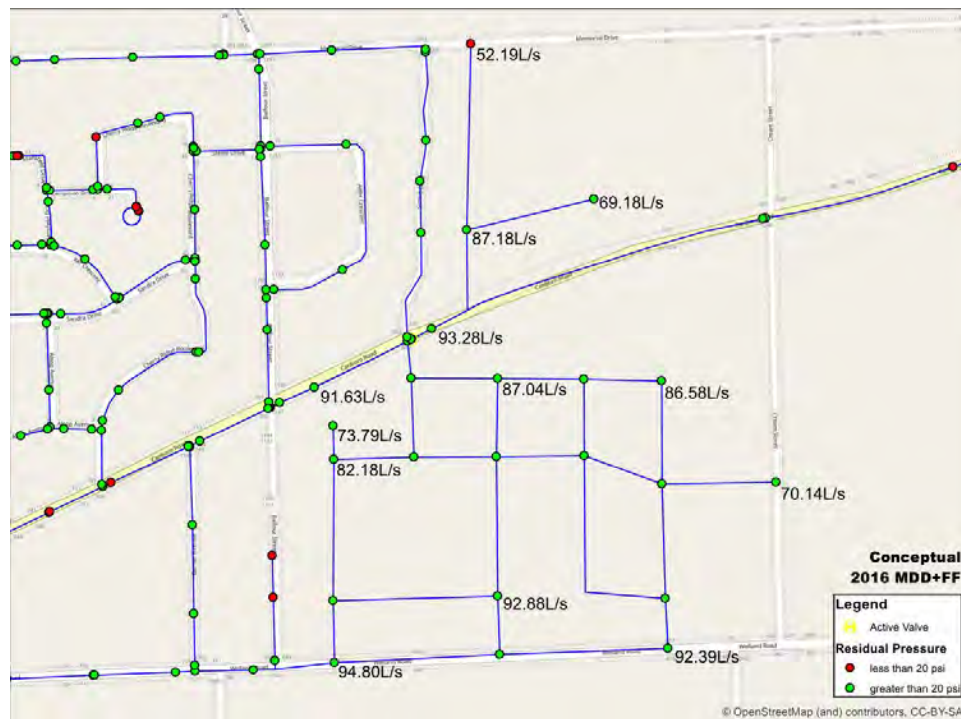
Figure 3-9: Conceptual 2016 MDD+FF
